Testing Results for 50ft

Smith & Wesson Security Solutions M50 Post and Cable System - 50 ft

TESTED TO: ASTM F 2656-07 Standard Test Method for Vehicle Crash Testing of Perimeter Barriers Test M50

> TEST REPORT NUMBER: TR-P32086-01-NC

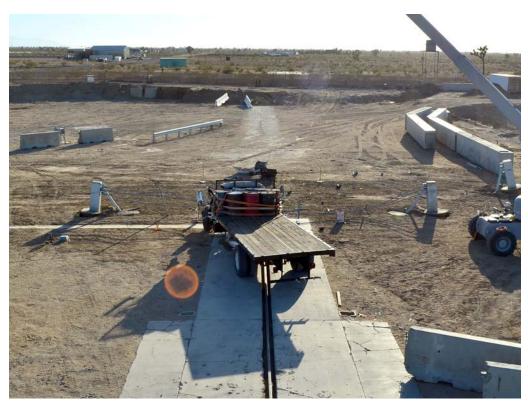
FIGURE 16. Post-Test

The test vehicle sustained severe damage and was completely disabled by the impact. The cables engaged the front of the engine block and pushed rearward into the cab of the truck. After impact the test vehicle was propelled backwards, away from the protected side of the fence.

The left and right side termination post and knee brace foundations shifted inward and toward the protected side of the fence. The right side knee brace deformed. Upon impact, each intermediate post sheared at the engineered break point, just above its respective foundation. The opening remained blocked during the impact. After the cables were dislodged from the test vehicle and the test vehicle was removed from the fence, the cables rested on the ground and the opening was not blocked.

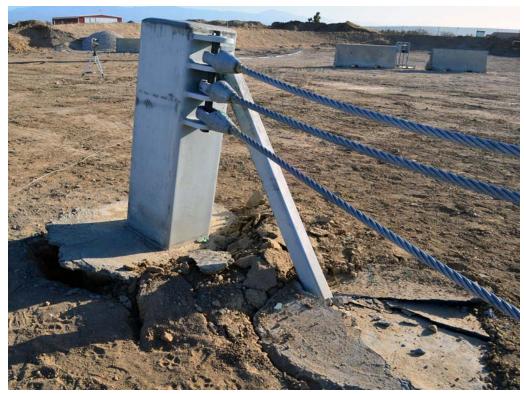
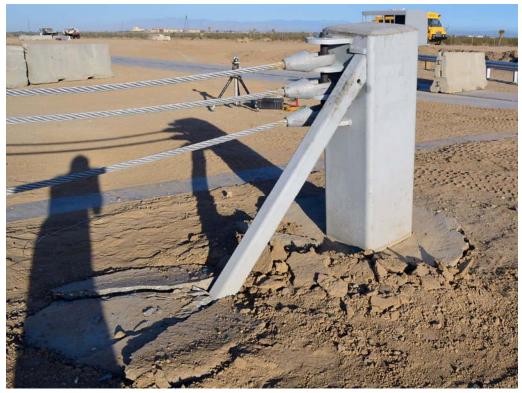
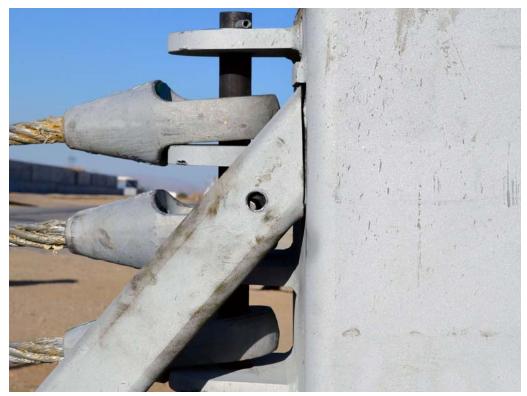
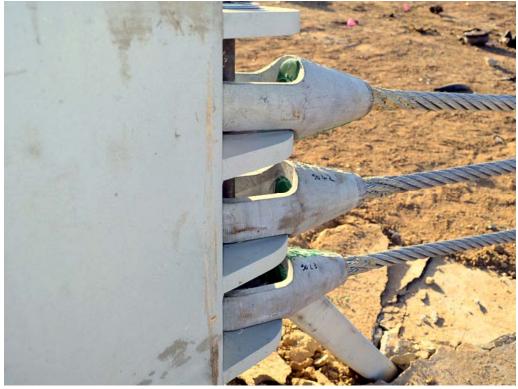
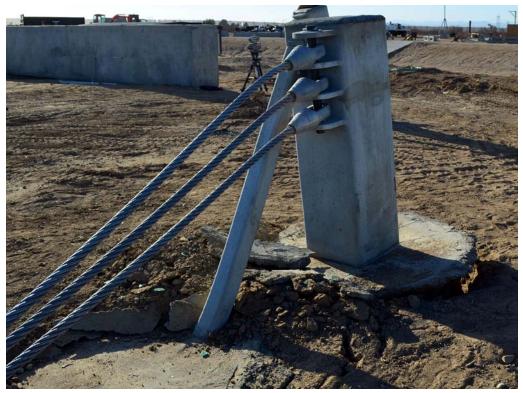
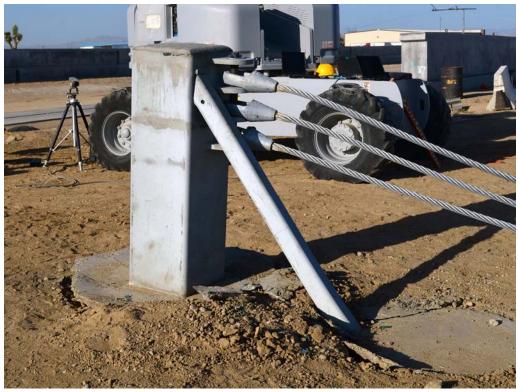
FIGURE 35. Test Article, Post-Test Damage

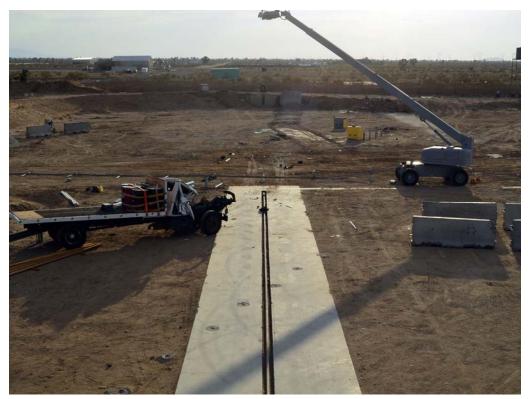
FIGURE 16. Post-Test

The test vehicle sustained severe damage and was completely disabled by the impact. The cables engaged the front of the engine block and pushed rearward into the cab of the truck. After impact the test vehicle was propelled backwards, away from the protected side of the fence.

The left and right side termination post and knee brace foundations shifted inward and toward the protected side of the fence. The right side knee brace deformed. Upon impact, each intermediate post sheared at the engineered break point, just above its respective foundation. The opening remained blocked during the impact. After the cables were dislodged from the test vehicle and the test vehicle was removed from the fence, the cables rested on the ground and the opening was not blocked.

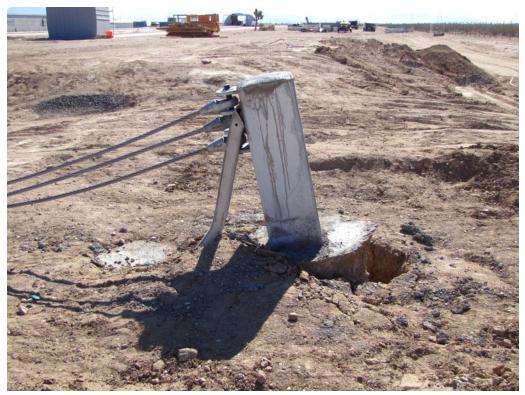
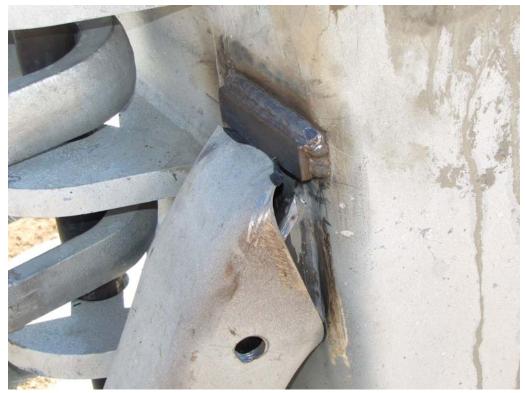
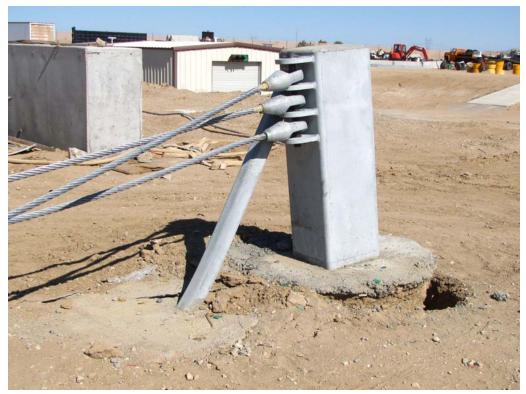
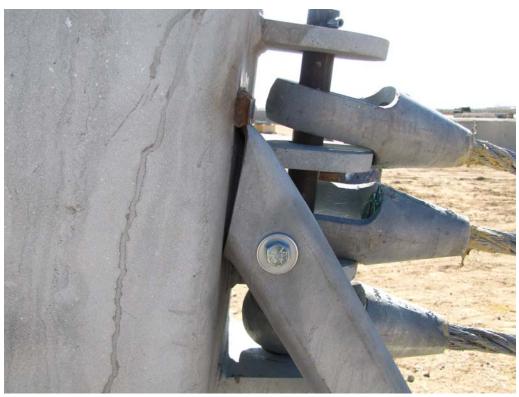
FIGURE 33. Test Article, Post-Test Damage
