3.4 Fencing

APPENDIX A: CASE STUDY – DAL: CABLE LOOP VEHICLE ARRESTING SYSTEM

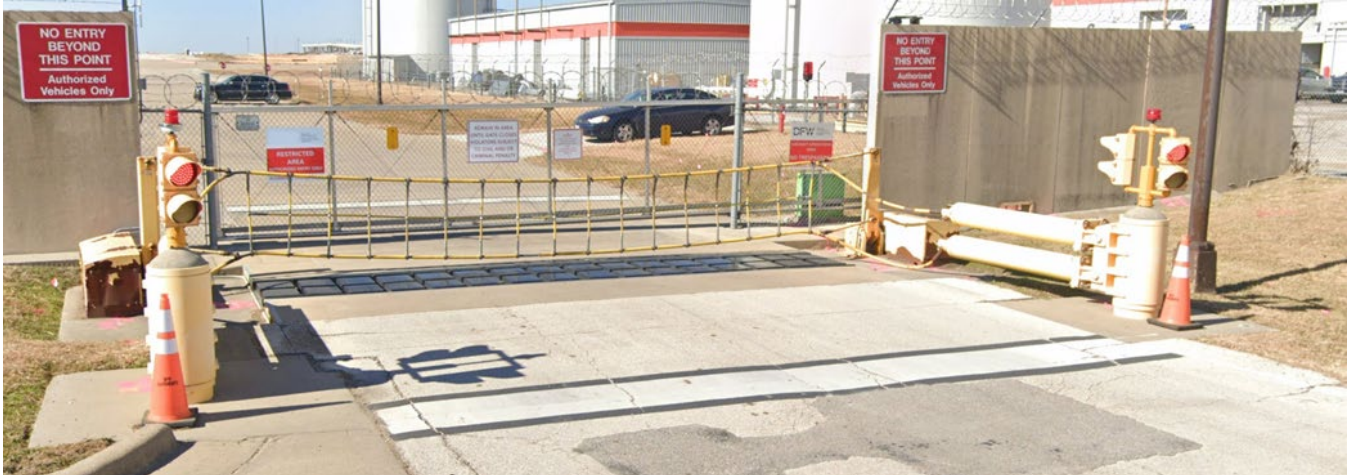
Figure 3-7. Net Barrier at a CAT X Airport

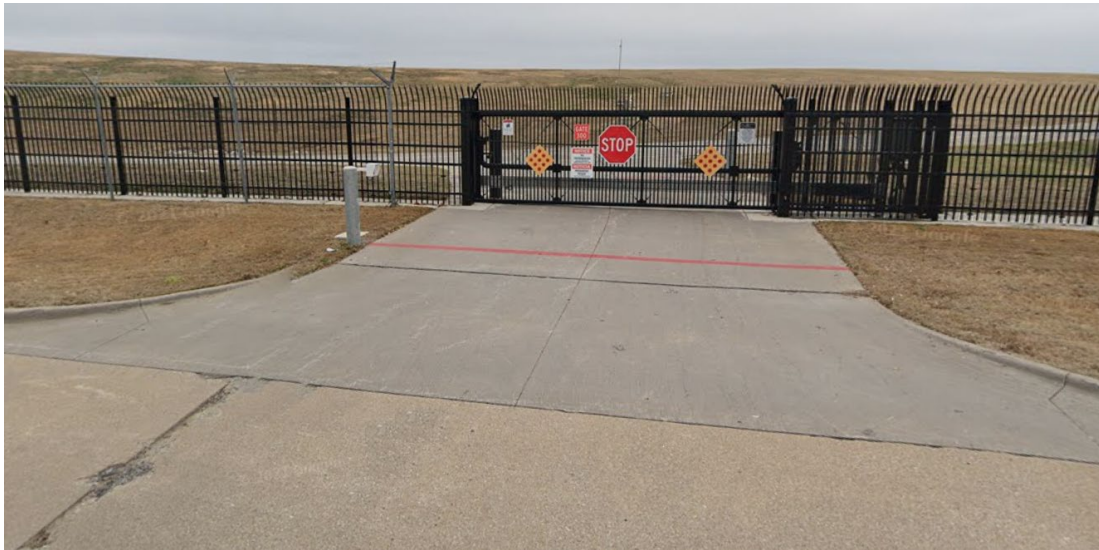
Figure A-1. Typical Perimeter Gate from Public Road to AOA

As an urban airport, Dallas Love Airport (DAL) faces the challenge of city streets that extend to the border of airport property (Figures A-1 and A-2).

Vehicle access gates that are near public streets need to be hardened against intrusion, whether intentional (e.g., vehicle ramming) or inadvertent (e.g., drunk drivers).

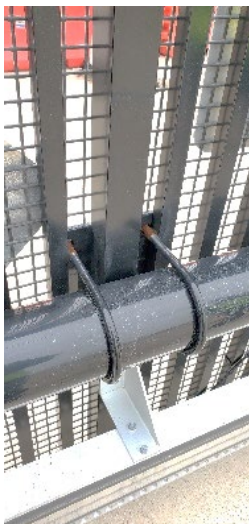
Figure A-4. Attachment via U-Bolts

The system attaches to the existing gates by U-bolts (Figure A-4) and moves with the gate during normal operations. If a vehicle attempts to breach the gate, the cable loop is caught by “horns” on ground anchors (Figure A-5) and the vehicle is stopped.

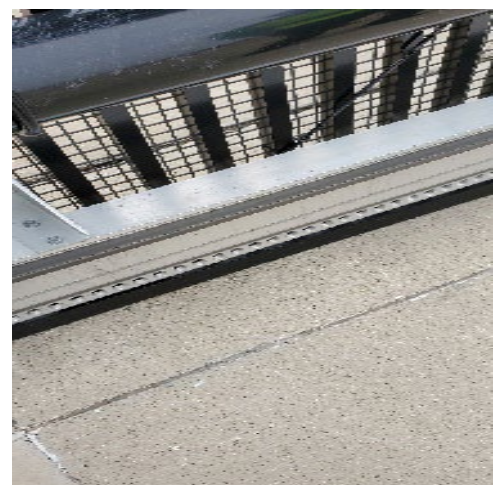
Figure A-6. Anti-Climb Mesh

Because the cable loop could provide footholds for a person attempting to climb the gate, anti-climb mesh was also added to the outside of the gate (Figure A-6).

Because the cable loop added potential footholds, anti-climb mesh was also added to the exterior side of the gate.
