PARAS 0039

Security, Operations, and Design Considerations for Airside Vehicle Access Gates

National Safe Skies Alliance, Inc.

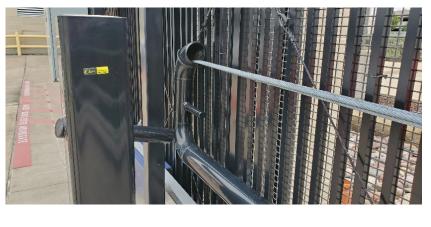
Figure A-6. Anti-Climb Mesh

Because the cable loop could provide footholds for a person attempting to climb the gate, anti-climb mesh was also added to the outside of the gate (Figure A-6).

Because the cable loop added potential footholds, anti-climb mesh was also added to the exterior side of the gate.
