**DOS K12/ASTM M50 TESTING AND EVALUATION OF
THE UNIVERSAL SAFETY RESPONSE 14 FT GRAB-300
BARRIER NET**

Contract No.: P2008131
Project/Test No.: 400001-USR14
Test Date: 2008-07-03

**TEXAS TRANSPORTATION INSTITUTE
THE TEXAS A&M UNIVERSITY SYSTEM
COLLEGE STATION, TEXAS 77843**

**DOS K12/ASTM M50 TESTING AND EVALUATION OF
THE UNIVERSAL SAFETY RESPONSE 62 FT GRAB-300
BARRIER NET**

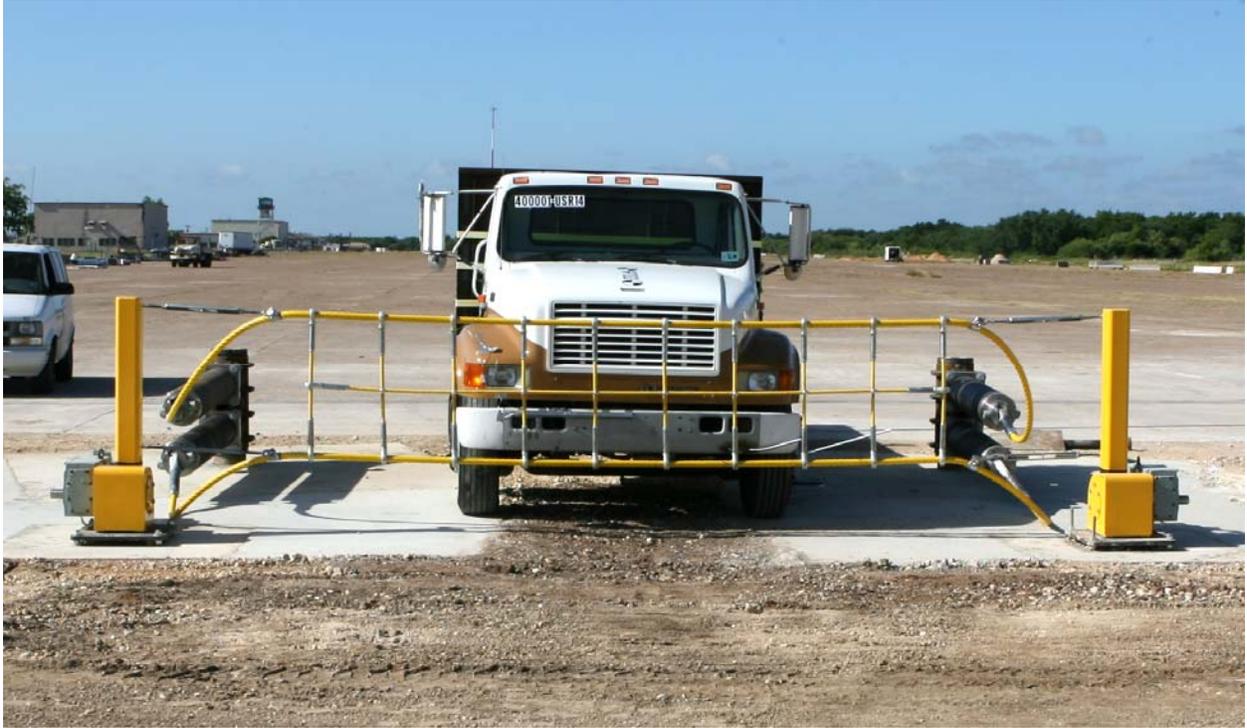
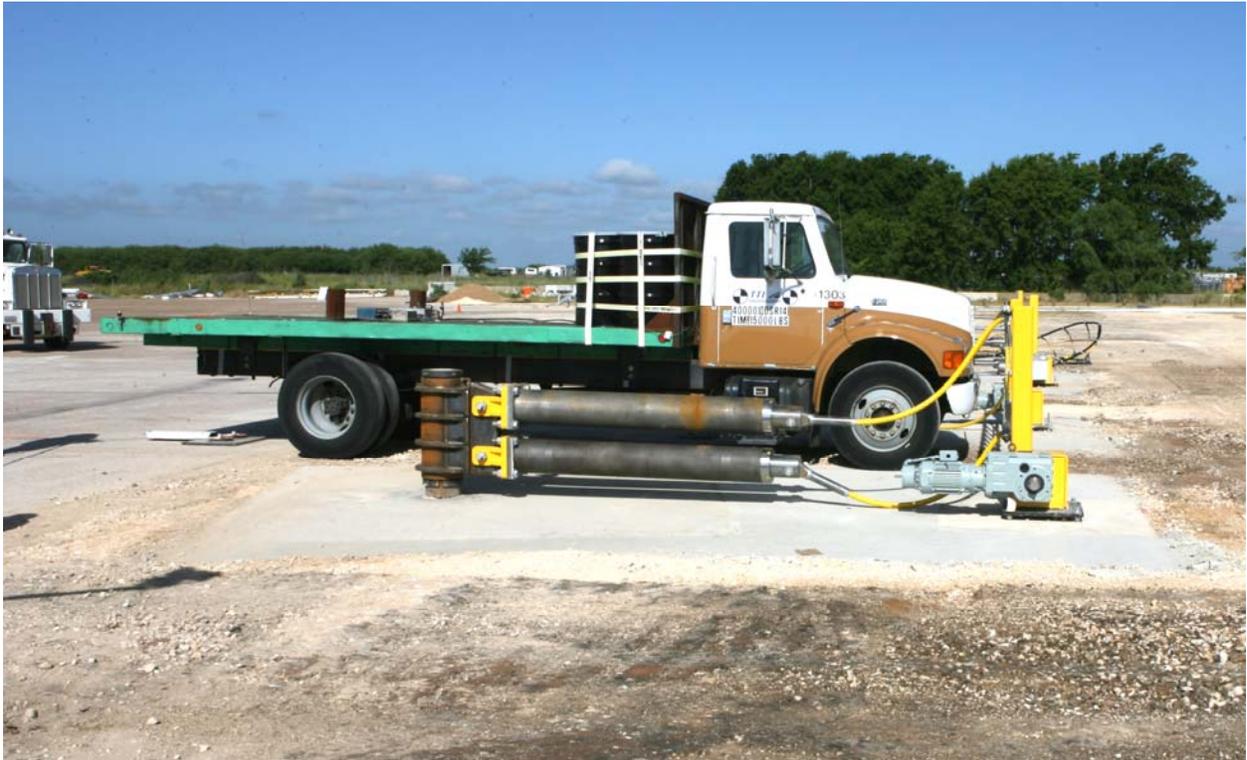
Figure 11. Vehicle/installation geometrics for test 400001-USR14.

A 1999 NaviStar 4700 single-unit flatbed truck, shown in figures 11 and 12, was used for the crash test. Test inertia weight of the vehicle was 6872 kg (15,150 lb). The height to the lower edge of the vehicle front bumper was 51 cm (20.25 inches), and the height to the upper edge of the front bumper was 80 cm (31.5 inches). Figure 18 in appendix B gives additional dimensions and information on the vehicle. The vehicle was directed into the installation using the cable reverse tow and guidance system, and was released to be free-wheeling and unrestrained just prior to impact.

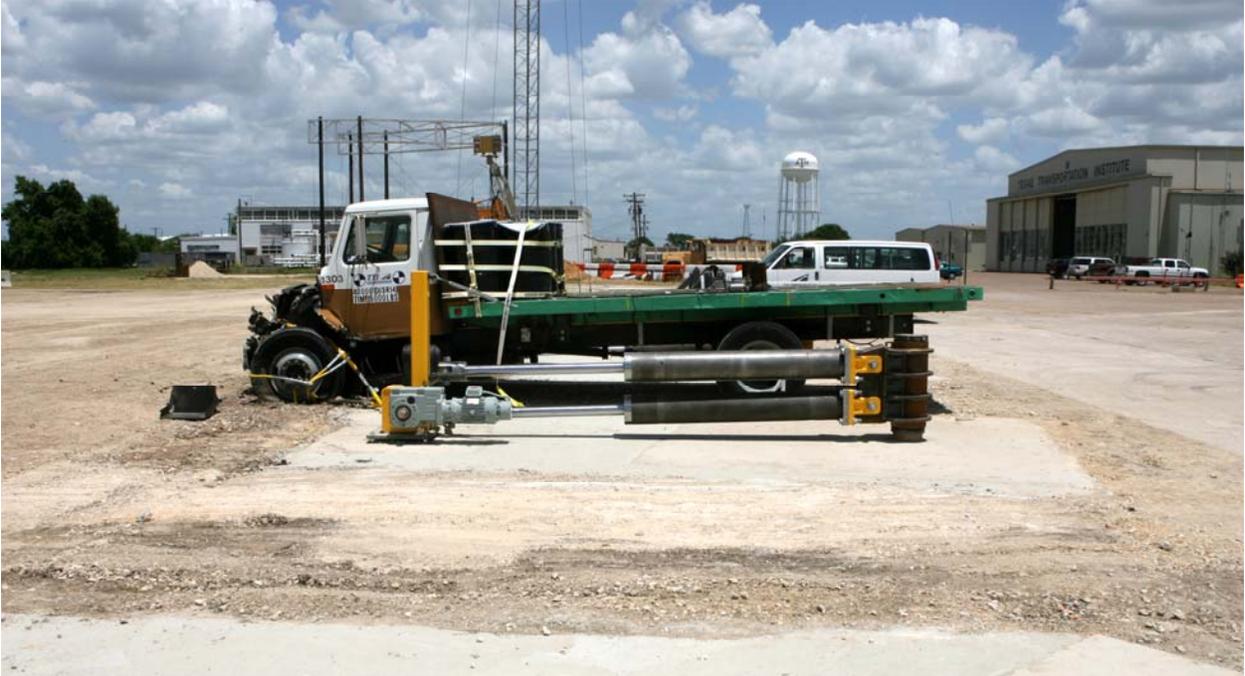
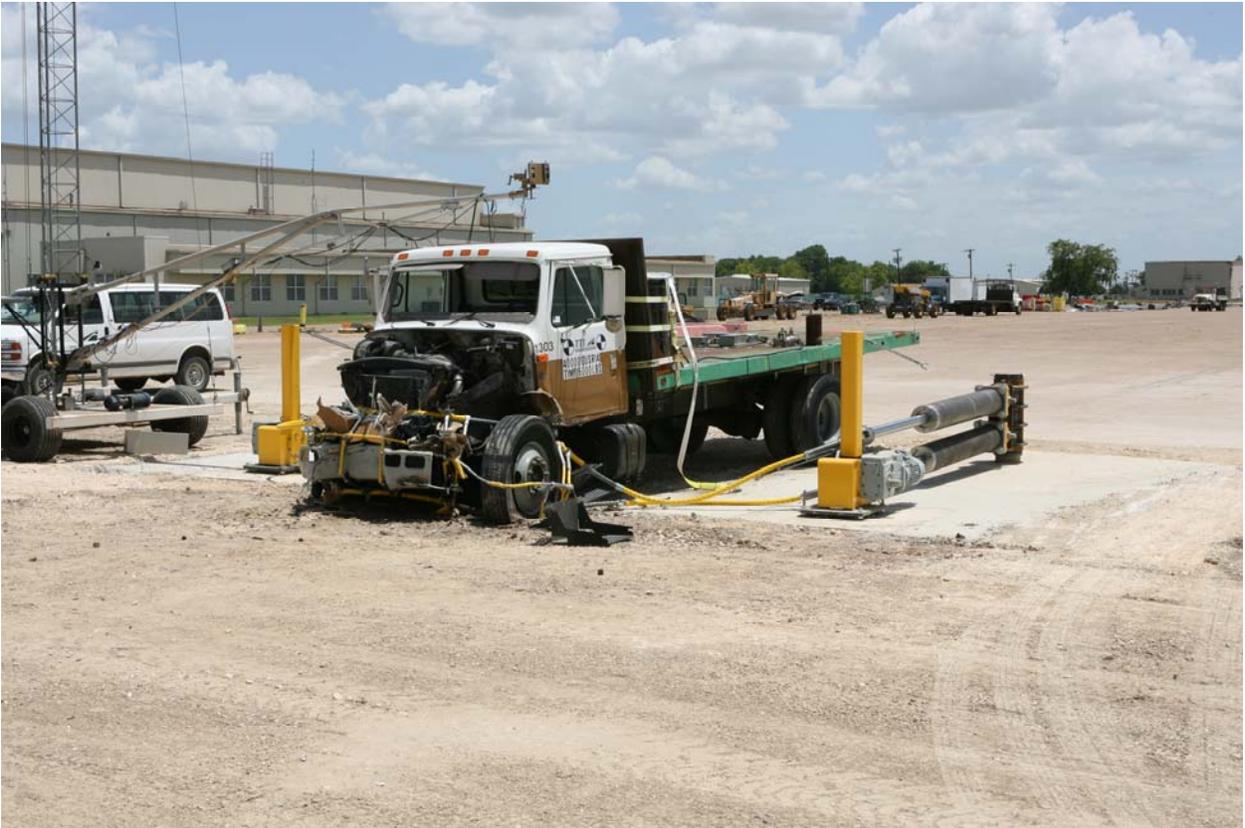
Figure 13. Vehicle/barrier after test 400001-USR14.

Damage to the GRAB-300 14-ft (4.3 m) barrier net is shown in figure 13 and 14. The left side shock absorber pulled out a maximum of 1.56 m (5.1 ft), and the right side 1.59 (5.2 ft) at approximately 0.292 s after impact. The barrier net remained on the vehicle as it rebounded and came to rest 0.10 m (0.3 ft) beyond the inside of the barrier on the left side, and 0.02 m (0.07 ft) forward of the inside of the barrier on the right side.

The acceptable range for impact speed for this Condition Designation K12 / M50 test was 75.0 km/h (50.0 mi/h) or above, and the actual impact speed was 80.6 km/h (50.1 mi/h). The 1999 NaviStar 4700 single-unit flatbed truck impacted the barrier at 89.1 degrees, with the centerline of the vehicle aligned with the centerline of the GRAB-300 14-ft (4.3 m) barrier net. The GRAB-300 14-ft (4.3 m) barrier net brought the vehicle to a complete stop. The cargo remained onboard the vehicle; however, the hood of the vehicle and parts of the barrier were thrown beyond the inside edge of the barrier. The front of the cargo bed penetrated beyond the inside edge of the barrier a distance of 1.4 m (4.6 ft).

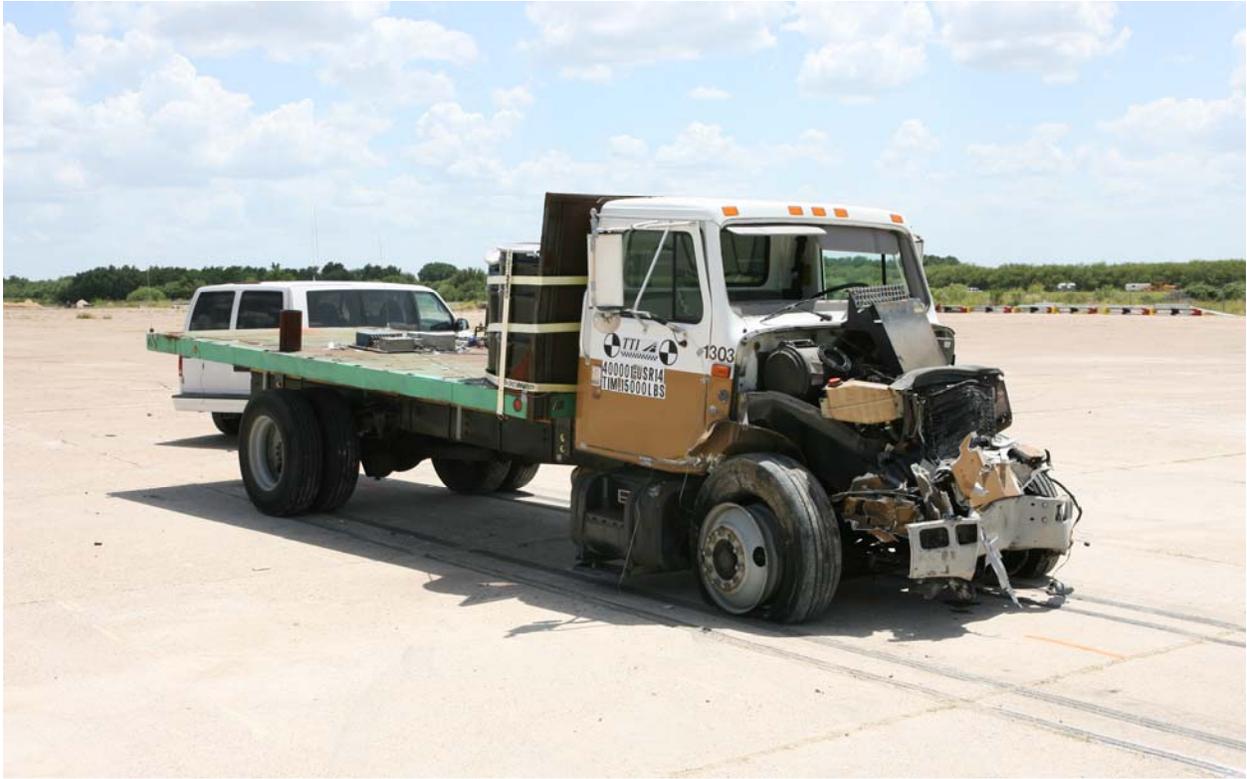
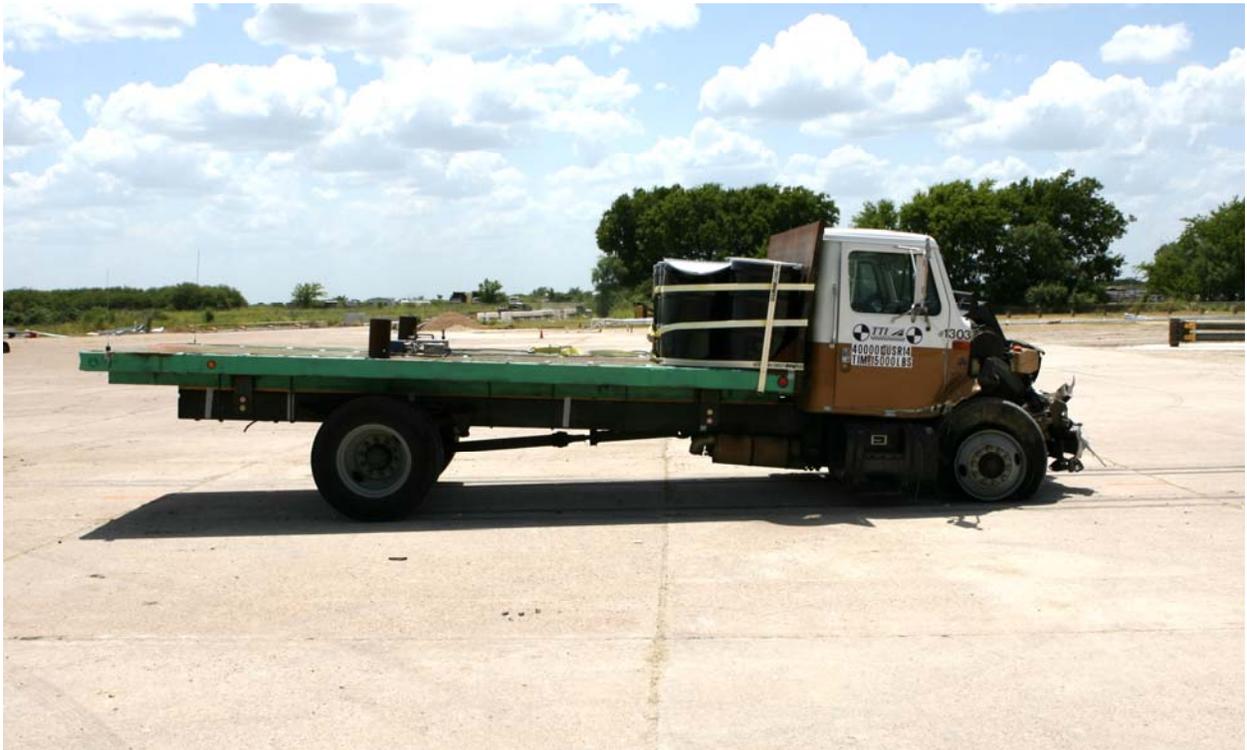
Figure 15. Vehicle after test 400001-USR14.

Damage to the 1999 NaviStar 4700 single-unit flatbed truck is shown in figure 15. The front tire and rim were pushed into the fuel tank on the right causing an indentation in the fuel tank. Both front tires were deflated. The left front spring mount broke, and the windshield popped out. Also damaged were the front bumper, hood, radiator, radiator support, fan and water pump, and the lower part of the cab. Maximum exterior crush to the vehicle was 8 inches (203 mm). Photographs of the interior of the vehicle are shown in figure 16.

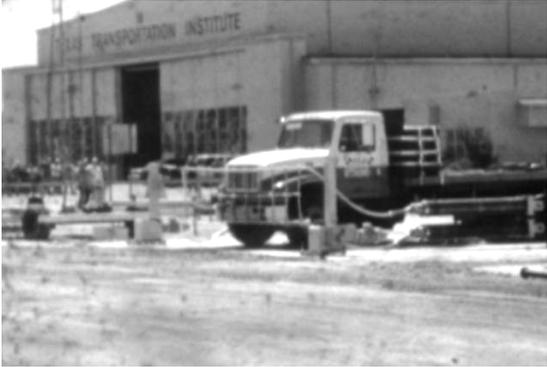
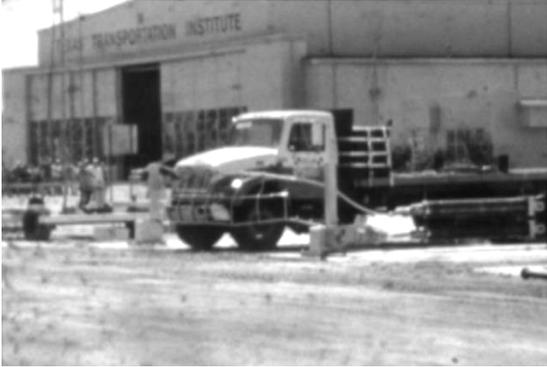
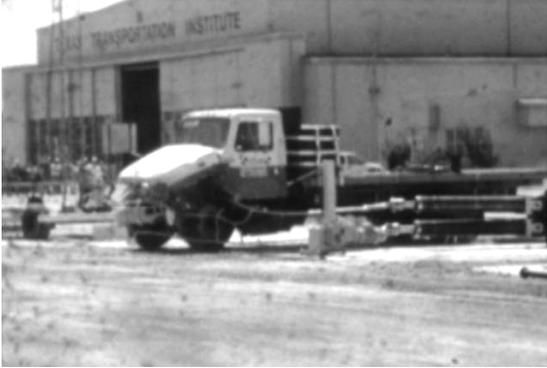
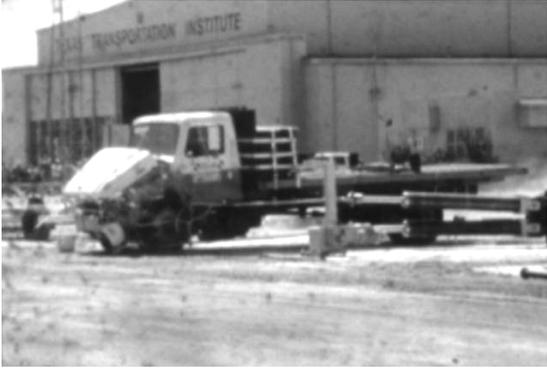
Figure 19. Sequential photographs for test 400001-USR14 (overhead and frontal views).

The 1999 NaviStar 4700 single-unit flatbed truck, traveling at an impact speed of 80.6 km/h (50.1 mi/h), impacted the GRAB-300 14-ft (4.3 m) barrier net at an impact angle of 89.1 degrees. The centerline of the vehicle was aligned with the centerline of the barrier net. At approximately 0.059 s after impact, the piston of the left side shock absorber began to pull out of its housing, and at 0.069 s, the right side began to pull out. Also at 0.069 s, the barrier net began to crush the front of the truck. The end of the shock absorber on the left side contacted the rear of the vehicle at 0.196 s, and the right side contacted the rear of the truck at 0.209 s. At 0.292 s, the vehicle reached maximum penetration into the net (1.59 (5.2 ft)), and at 0.319 s, the vehicle began to rebound. The rear of the vehicle reached maximum pitch height at 0.0687 s, and the vehicle came to rest at 1.068 s. At rest, the vehicle was 0.10 m (0.3 ft) beyond the inside of the barrier on the left side, and 0.02 m (0.07 ft) forward of the inside of the barrier on the right side. Appendix C, figure 19, show sequential photographs of the test period.

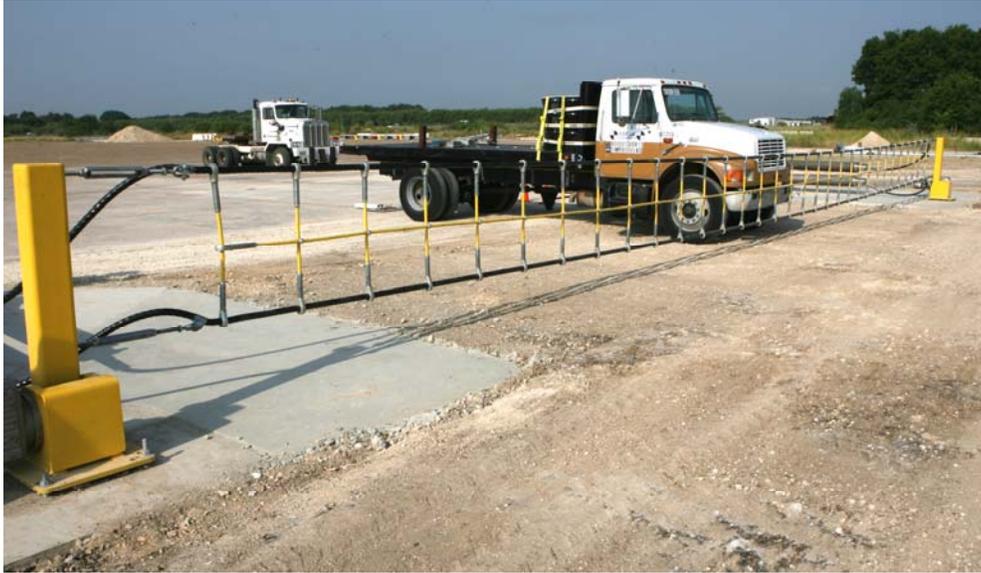
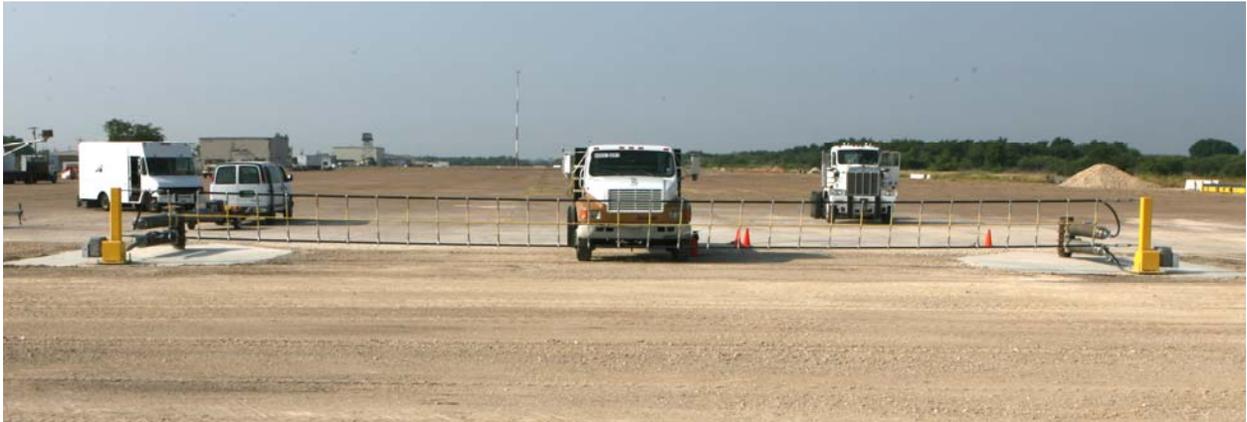
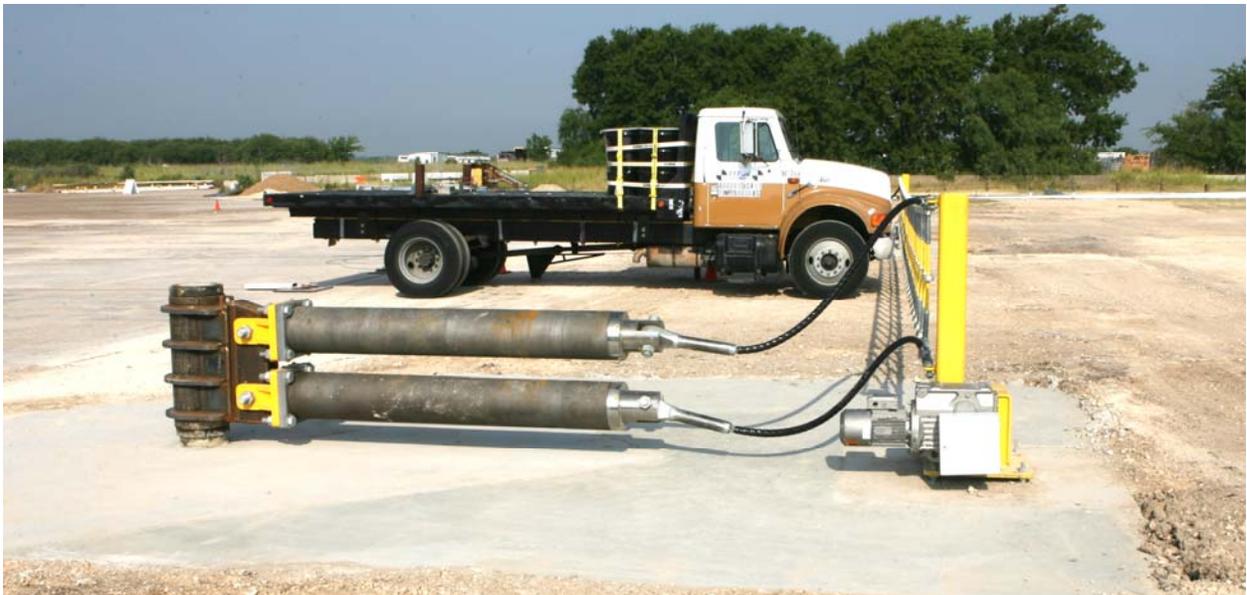
Figure 11. Vehicle/installation geometrics for test 400001-USR13.

A 1997 NaviStar 4700 single-unit flatbed truck, shown in figures 11 and 12, was used for the crash test. Test inertia weight of the vehicle was 6804 kg (15,000 lb). The height to the lower edge of the vehicle front bumper was 51 cm (20.25 inches), and the height to the upper edge of the front bumper was 80 cm (31.5 inches). Figure 18 in appendix B gives additional dimensions and information on the vehicle. The vehicle was directed into the installation using the cable reverse tow and guidance system, and was released to be free-wheeling and unrestrained just prior to impact.

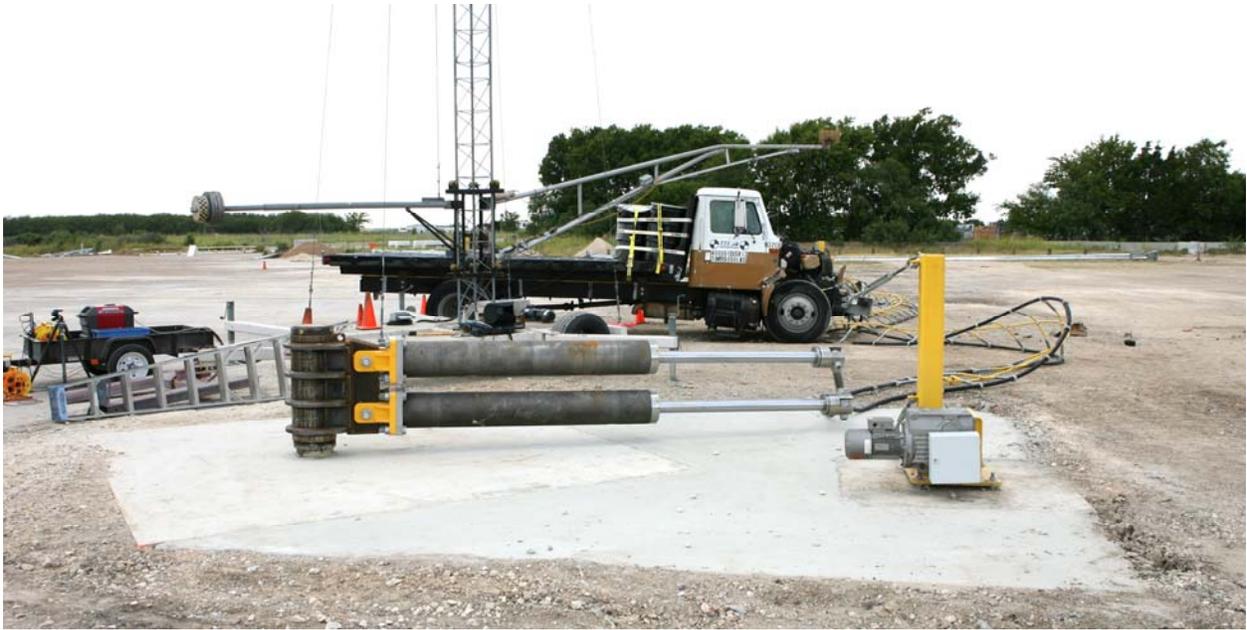
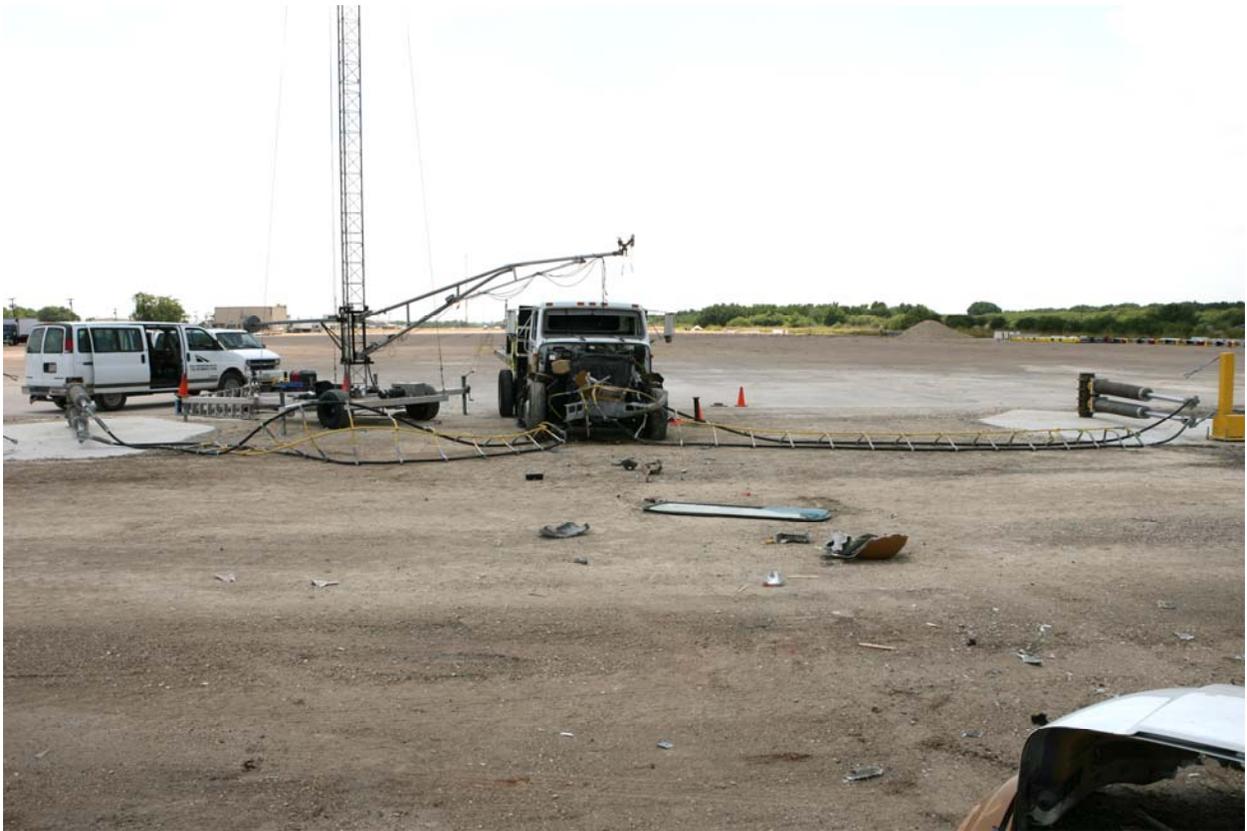
Figure 13. Vehicle/barrier after test 400001-USR13.

Damage to the GRAB-300 62-ft barrier net is shown in figure 13 and 14. The top right shock absorber pulled out 56.75 inches, the bottom right 58.38 inches, the top left 59.63 inches, and the bottom left 59.63 inches. The net remained intact, but was caught in the vehicle, grill and bumper. Very slight movement was noted in the right post (less than 1 degree of lean inward). Maximum dynamic penetration of the GRAB-300 62-ft barrier net was 20.9 ft (6.4 m). The vehicle then rebounded back close to the original impact location.

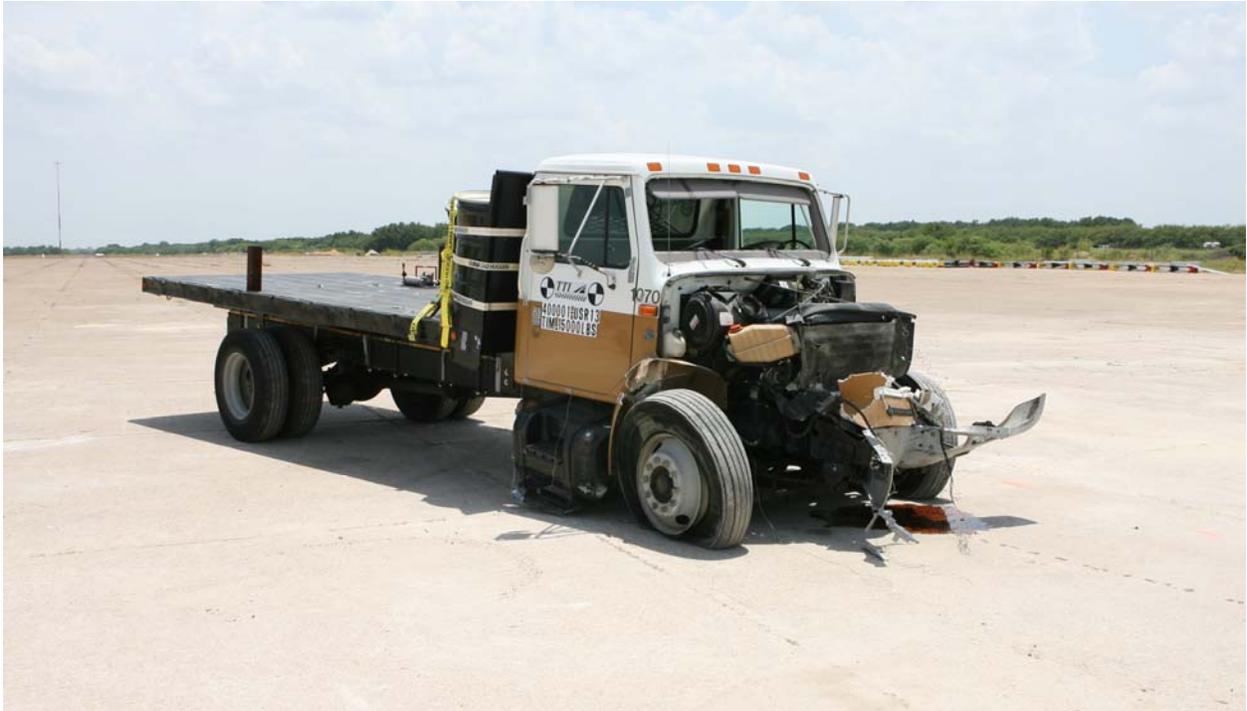
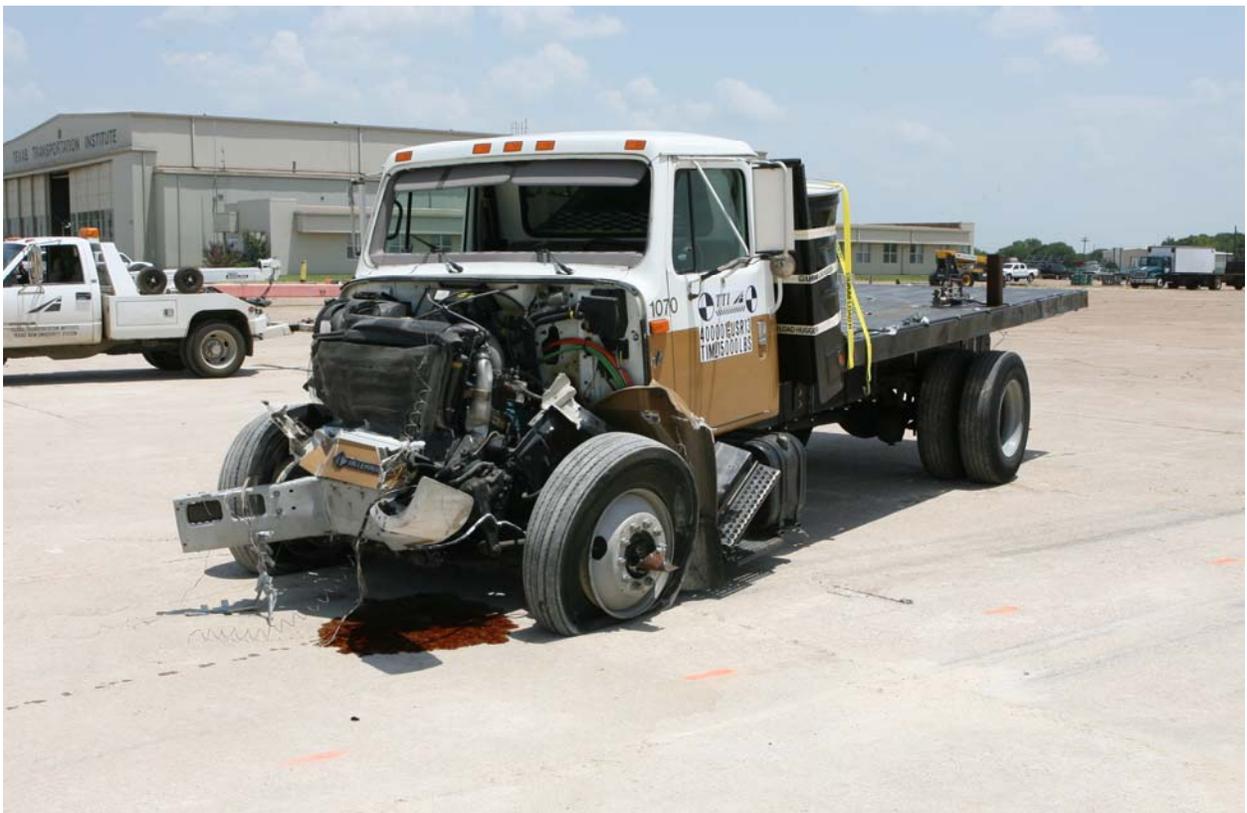
Figure 15. Vehicle after test 400001-USR13.

Damage to the 1997 NaviStar 4700 single-unit flatbed truck is shown in figure 15. The flatbed was deformed toward the front along the cargo rack, and the rear of the cab was deformed inward. The windshield popped out, and there was a cut in the fuel tank. The right front spring mount was broken. Also damaged were the front bumper, hood, radiator, radiator support, and fan-water pump. Maximum exterior crush to the vehicle was 10 inches. Photographs of the interior of the vehicle are shown in figure 16.

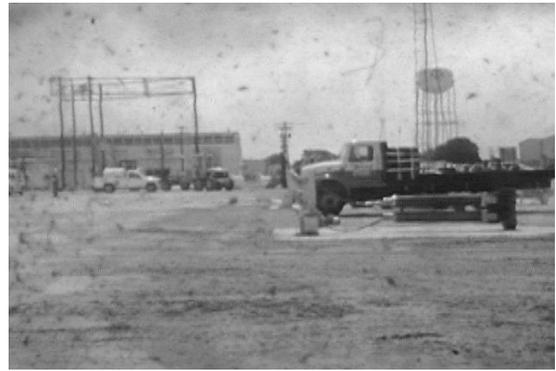
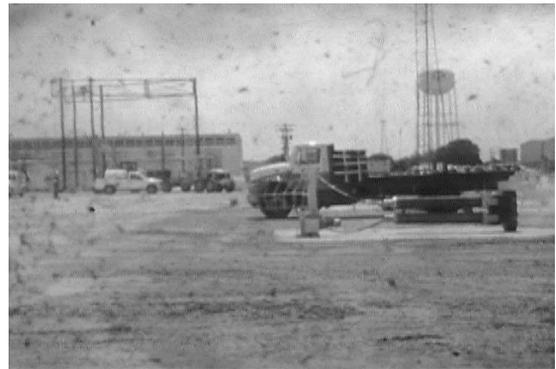
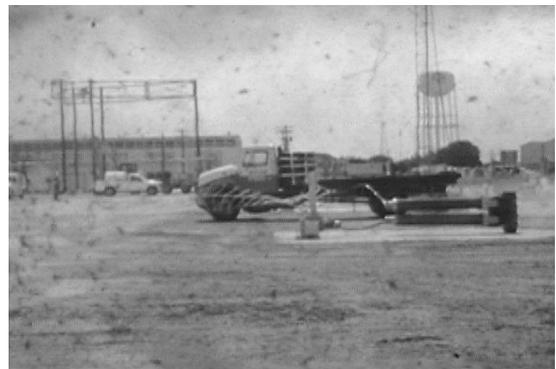
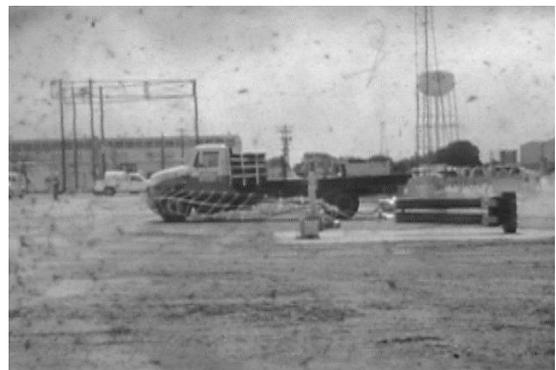
Figure 19. Sequential photographs for test 400001-USR13 (overhead and frontal views).

The 1997 NaviStar 4700 single-unit flatbed truck, traveling at an impact speed of 83.2 km/h (51.7 mi/h), impacted the GRAB-300 62-ft barrier net at an impact angle of 90.5 degrees. The centerline of the vehicle was aligned with the centerline of the net. Shortly after impact, the middle cable began to tighten around the front of the vehicle, and at 0.007 s, the top and bottom cables began to deform around the front of the vehicle. At 0.162 s, the truck began to yaw counterclockwise, and at 0.378 s, the middle cable was taut around the front of the vehicle. Forward motion of the truck stopped at 0.504 s, and the vehicle began to rebound at 0.508 s. The vehicle subsequently came to rest 0.68 m (2.23 ft) forward of the barrier net (on the impact side of the installation). Appendix C, figure 19, shows sequential photographs of the test period.
